ANALYSIS OF LIQUID ROCKET TANKAGE FOR MODEL  
LR58-RM-4 LIQUID PROPELLANT THRUST UNIT FOR THE  
BULLPUP MISSILE

Bell Aerospace Company

AFRPL-TR-75-73

FINAL REPORT

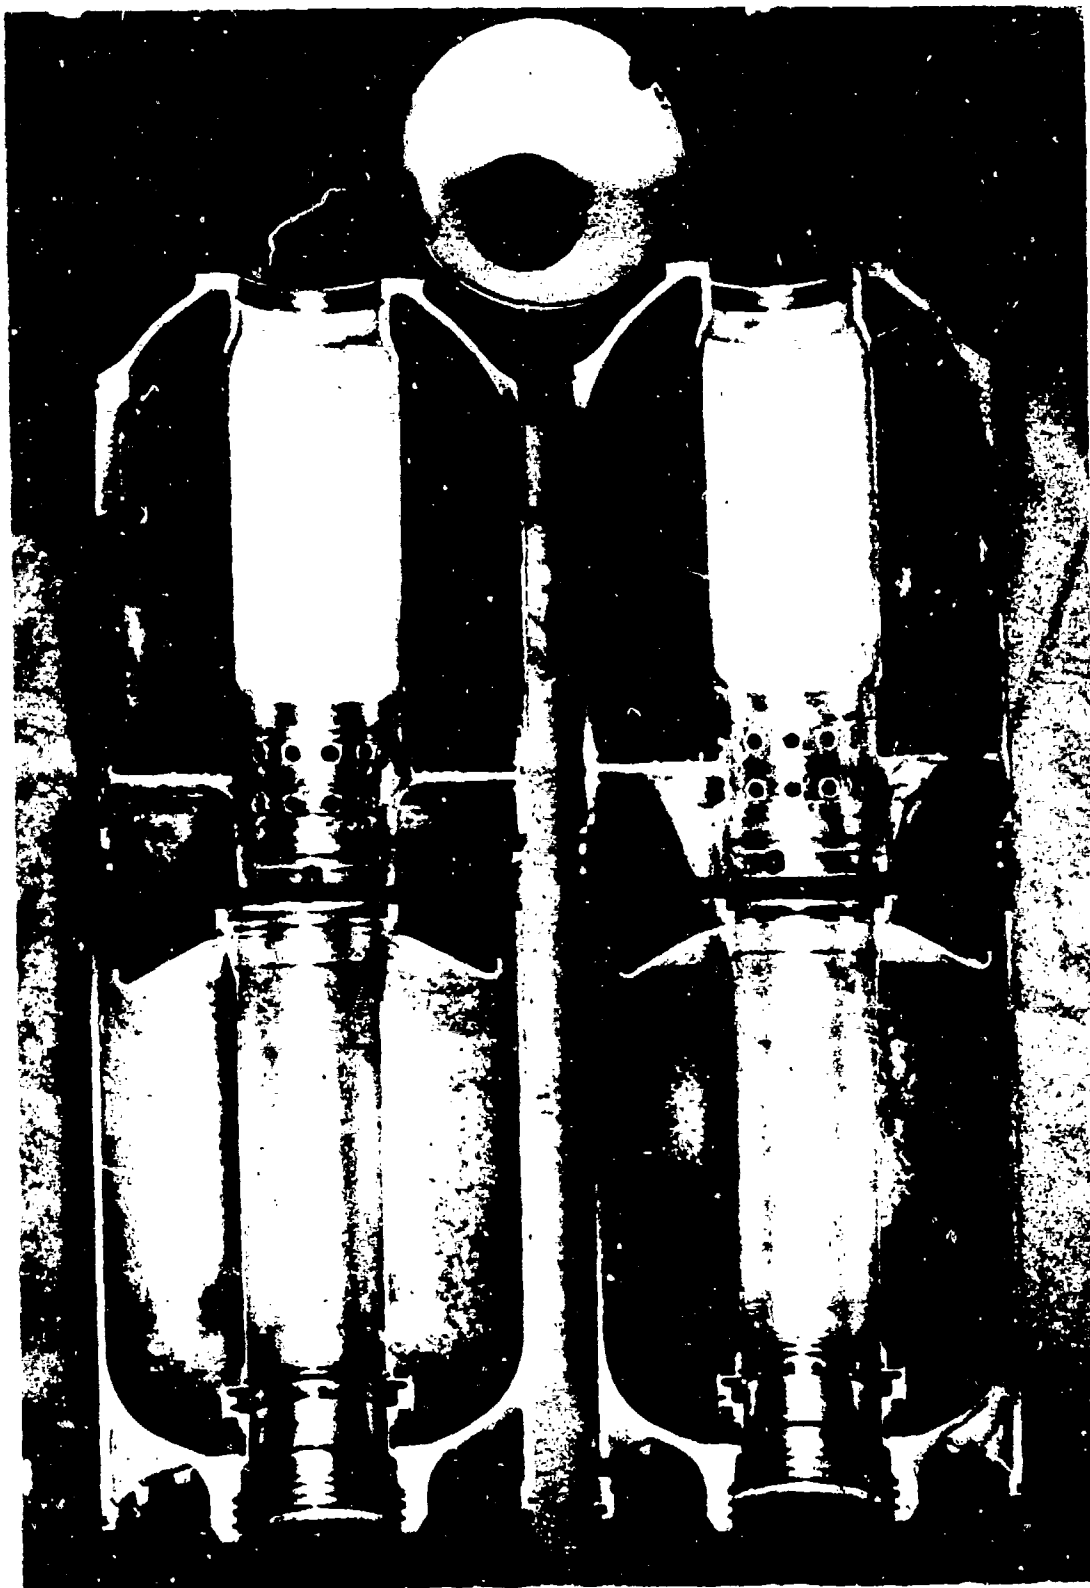
FIGURE 2. SECTIONED VIEW OF THRUST UNIT SHOWING INTERIOR  
CONDITION AFTER 10-YEAR STORAGE WITH PROPELLANTS.

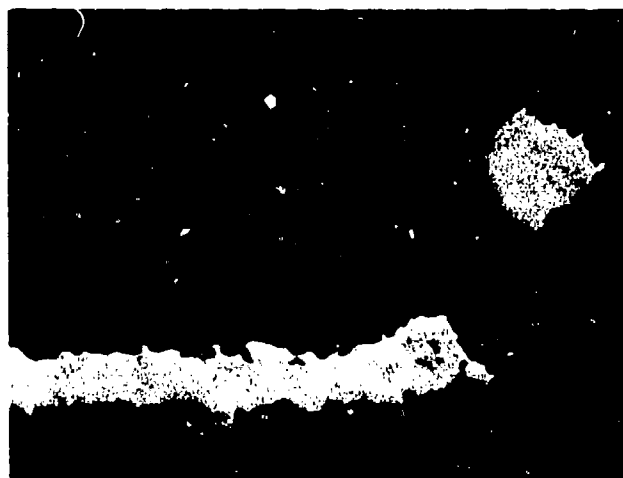
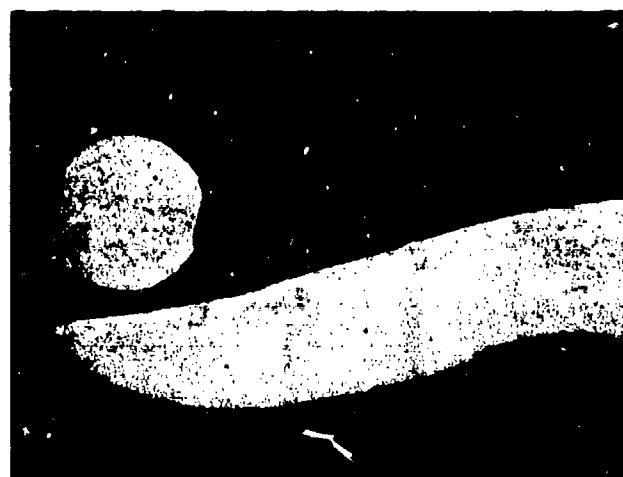
FIGURE 10. COMPARATIVE CROSS SECTIONS OF CORRODED AND  
NON-CORRODED SCREEN MATERIAL SHOWN IN FIGURE 9.

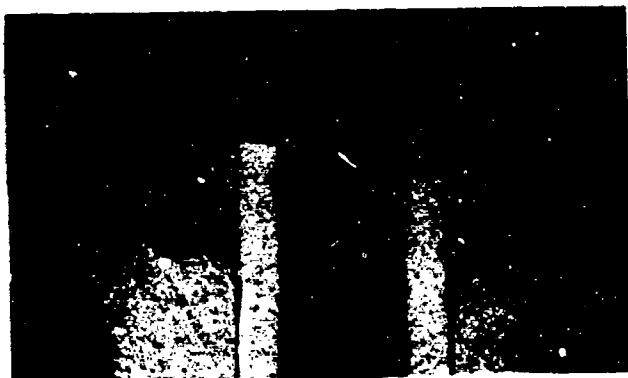
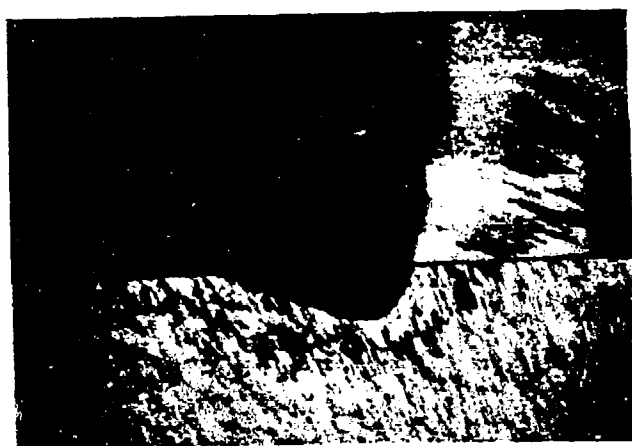
above. No unusual conditions were observed except for some minor end grain attack of the radiused area machined into the forward, oxidizer inlet, pressurizing passage component. This area exposed to the IRFNA oxidizer, is located immediately adjacent to the burst band weld joint and is shown in Figure 14.

FIGURE 14. SECTIONS THROUGH VARIOUS STRUCTURAL WELDS IN OXIDIZER  
TANK OF BULLPUP MISSILE. ALL MATERIALS ARE ALUMINUM  
ALLOYS.

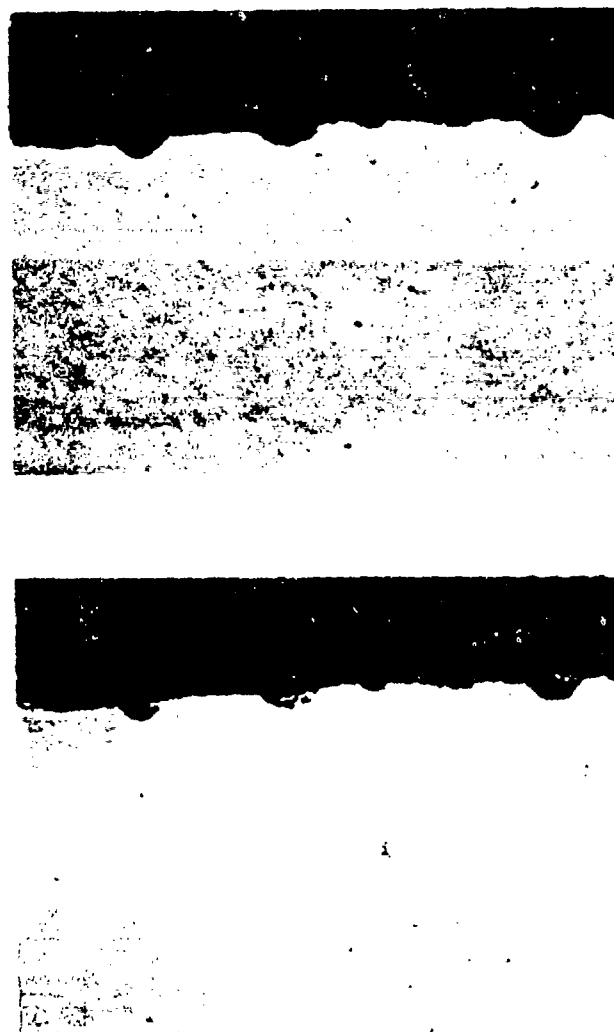
FIGURE 21. VERY SHALLOW PITTING CORROSION OBSERVED ON 2014-T6 ALUMINUM ALLOY FUEL TANK FROM BULLPUP MISSILE. EXPOSED TO MAF-1 FUEL FOR TEN YEARS. CORROSION LAYER IN BOTTOM VIEW IS DARK GRAY AS OBSERVED VISUALLY.
